US Army Corps
of Engineers®
Engineer Research and
Development Center

Laboratory and Field Evaluation of In-Place Asphalt Recycling Technologies for Small Airfield Repair

June 2013

Final report

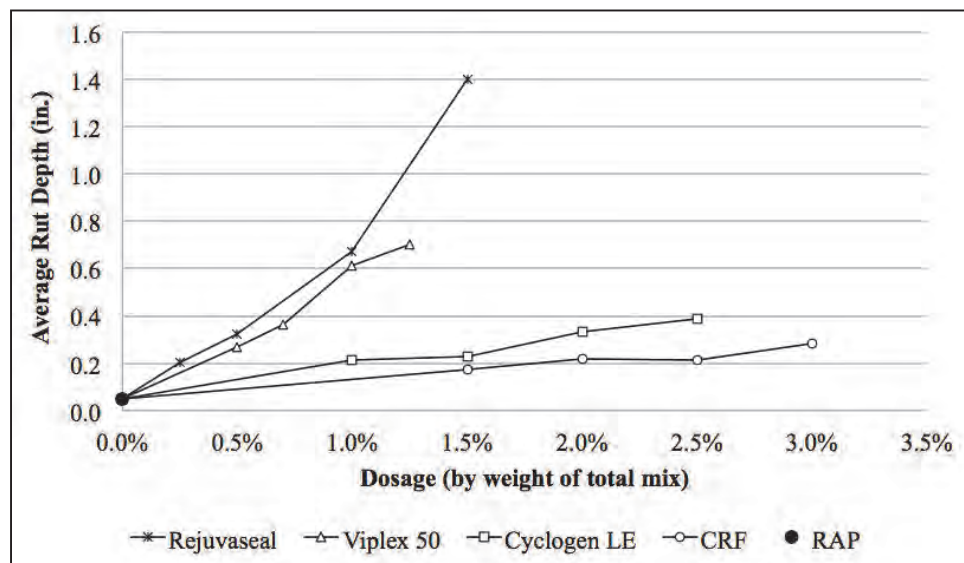
Figure 10. Maximum rut depth for all mixes tested.

Test data from the APA are listed in Table 6. The average maximum rut depth for each of the recycled mixes was determined and is presented in Figure 10. Six-in.-diam by 4- to 6-in.-thick core samples were obtained from the Vicksburg Municipal Airport test site. These core samples were trimmed down to a height of 3 in., and APA testing was conducted on the uncut face of the cores. The test results were used to represent the rutting behavior of the existing asphalt pavement material without rejuvenator. These results are presented in Figure 10 as “RAP”.

Rut depth results showed an increase in rutting as the rejuvenator dosage was increased for all four rejuvenators. A small change in dosage of the oil base and coal tar-based products tended to rejuvenate the RAP mix to a point where it rutted excessively compared to the two water-based products. Based on their consistent lower rut depths at different rejuvenator dosages compared to the other products, the top performing rejuvenators among those tested were Cyclogen LE and CRF.

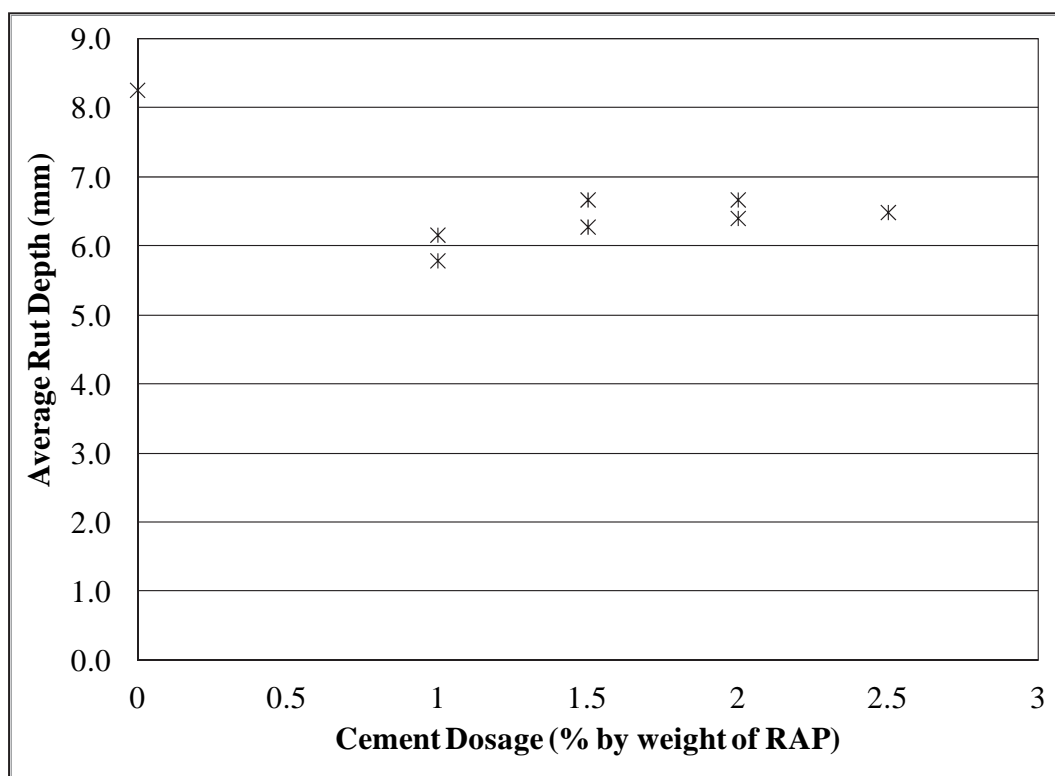
Figure 21. APA average rut depth of rejuvenated RAP (with 0.5 percent RejuvaSeal) and different dosages of Type I Portland cement.

Table 8 displays the APA maximum rut depths and the average air voids obtained. Cyclogen and CRF exhibited an increase in rutting potential due to the addition of cement. In contrast, Rejuvaseal, a coal tar based product, appeared to benefit from cement addition. Based on these results, further testing at additional cement contents was performed only with Rejuvaseal, as shown in Table 8 and in Figure 21. At cement contents above 1 percent, rutting potential appeared to be similar to the results observed at 1 percent. Since there appeared to be no considerable advantage to be gained by adding additional cement, a cement content of 1 percent with 0.5 percent Rejuvaseal was selected to use for field testing.

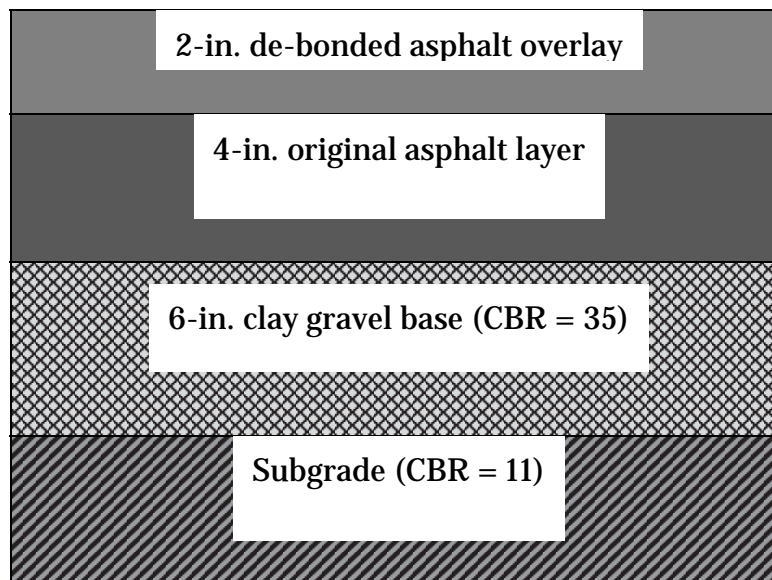
Figure 24. Pavement structure at Test Site 1.

The existing surface was extremely raveled and loose aggregate was abundant as shown in Figure 23. Dynamic cone penetrometer (DCP) tests revealed a weak subgrade layer of material with a California Bearing Ratio (CBR) of 11 (Figure 24). An initial core investigation of the site identified varying pavement thicknesses from 4 to 6 in., but later the original pavement was determined to be 4-in. thick, later covered with a 2-in. overlay that was now partially de-bonded. The base course consisted of a compacted, unstabilized layer of clay gravel with a CBR of 35, and the subgrade consisted of a silt with a CBR of 11.

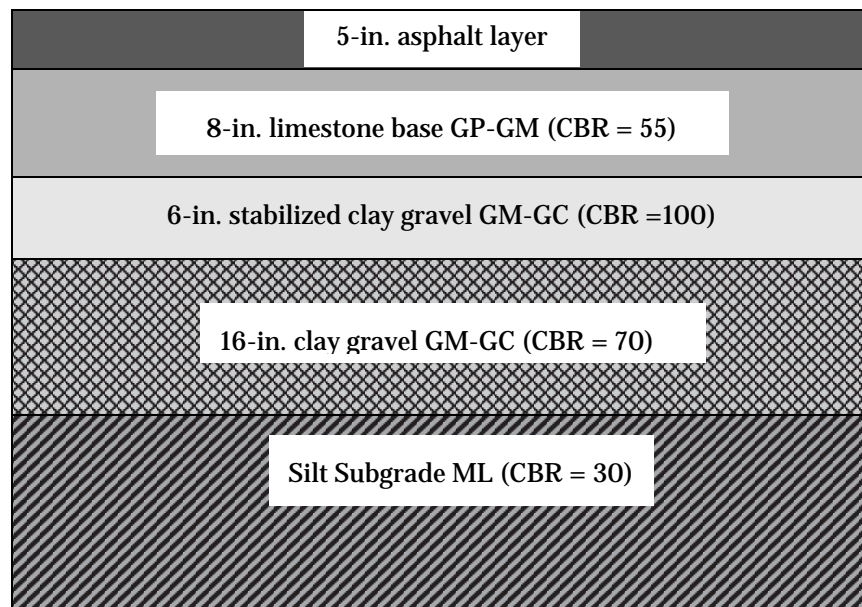
Figure 25. Pavement structure at ERDC test site.

The existing pavement was excavated from the repair area to a depth of 6 in. All the excavated material was discarded as the RAP materials to be used for the evaluation were brought from another area within ERDC and from Test Site 1. Excavation was performed without heat and using a saw to cut the repair perimeter in advance. Dynamic Cone Penetrometer (DCP) testing was conducted in-situ to evaluate the strength of the pavement foundation layers. The results are shown in Figure 25. Failure was predicted using the CBR-Beta Procedure (UFC 3-260-03), and the base layer controlled it with only 912 passes of the F-15E aircraft with a gross weight of 35,235 lb and tire pressure of 325 psi. Results from this analysis are listed in Table 10.

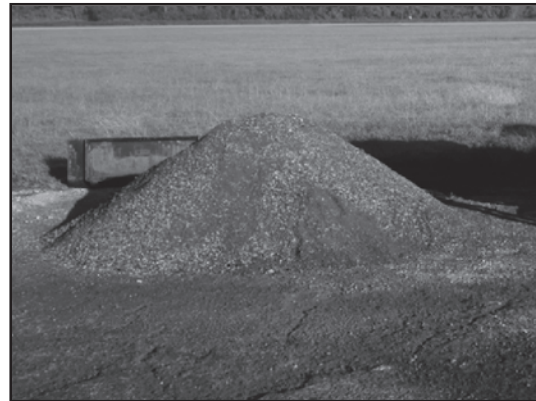
Figure 34. Spoil pile from site sweeping.

Due to the extensive raveling and loose aggregate on the apron surface, the entire site was swept using a skid steer-mounted broom attachment (Figure 33). The sweeping effort collected most of the loose material for offsite disposal. Removing debris from the pavement surface was important to prevent aggregate with little or no bonded asphalt from being included in the rejuvenation process. Uncoated aggregates in the final asphalt mix reduced the net asphalt content and ultimately decrease final performance of the repair. The removal of this debris also allowed the infrared heat to permeate directly into the existing asphalt layer, rather than being absorbed into the surface area of the loose aggregates. This increased overall heating efficiency and decreased time needed for sufficient heating. A photo of the loose material recovered from the repair site (Figure 34) illustrates the magnitude of site deterioration as well as the severity of overlay erosion and wear.

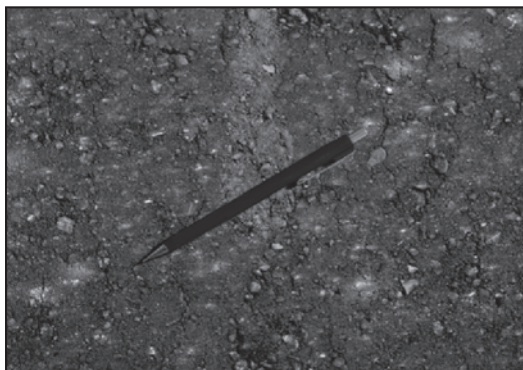
Figure 55. Post-compaction surface cracks (FD-2).

After compacting repair FD-2, surface cracking was abundant, and a considerable amount of uncoated aggregates were present. Figure 55 shows a scaled close-up of the final repair surface for FD-2. In an effort to mitigate the cracking and improve surface integrity, CRF was placed into a pressure

sprayer and applied lightly to the repair surface (Figure 56). The rejuvenator was allowed to penetrate the surface and become tacky before the roller was used to compact one final time. This effort was completed without vibration to prevent additional cracks from forming. When completed, the repair surface was again inspected visually, and the technique had sealed many of the visible cracks.

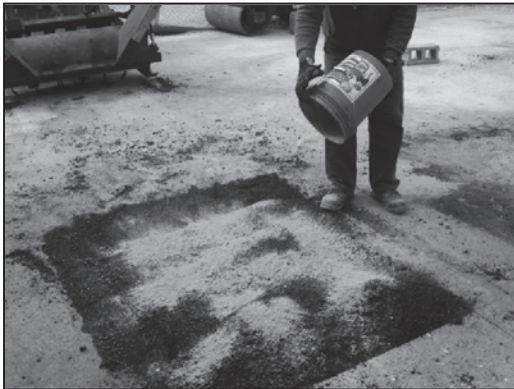
Figure 61. Cement addition to PHP-4.

PHP-4 was performed using 0.5 percent Rejuvaseal and 1 percent Type I Portland cement. The repair method specified that the cement and rejuvenator be mixed into the RAP using the mixing drum prior to placement. The first three batches were produced without issue. During the fourth batch, the chain on the skid steer-mounted mixing drum broke and was beyond field repair. The batch remaining in the drum was poured onto the stockpile, and the rejuvenation process was finished in the repair void itself using the propane heater and asphalt processor unit.

The remaining RAP material needed was weighed in 5-gal buckets, emptied on the stockpile cold and pushed into the void using a skid steer and bucket. The heater was then placed over the repair area to slowly bring the cold RAP to temperature. To avoid scorching the surface material, the heater was periodically removed and the processor was used to mix the mass. Once the RAP had reached an average internal temperature of 250°F, the heater was removed, and the cement and rejuvenator dosages were added as seen in Figure 61 and Figure 62. The cement was added first. The RAP was then processed again to ensure a homogeneous mixture.

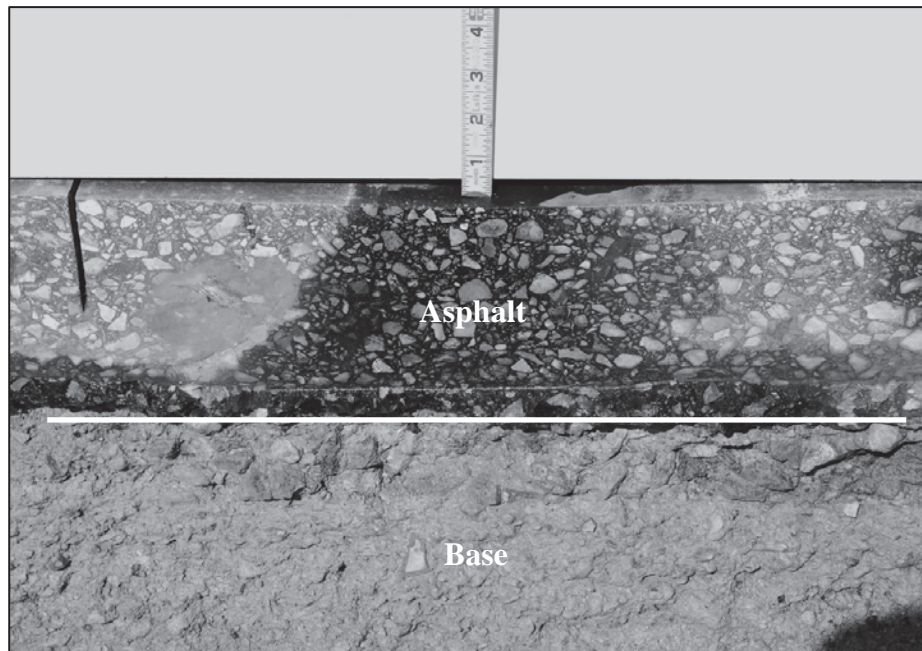
Figures 75 to 76 show the trenched cross-section view of repairs at the ERDC test site after failure. The white lines delineate the boundary between the asphalt and base layers. Shear deformation was not evident in the asphalt pavement, and no deformation was observed at the bottom of the asphalt layer. Therefore, the small amount of deformation observed at the surface of the asphalt layer was attributed to compaction of the asphalt mix. The surrounding asphalt pavement rutted equal to or greater than all the repairs (except for PHP-4) as shown in Figure 78.

Figure 75. Repair PHP-1 trenched cross-section view post traffic.

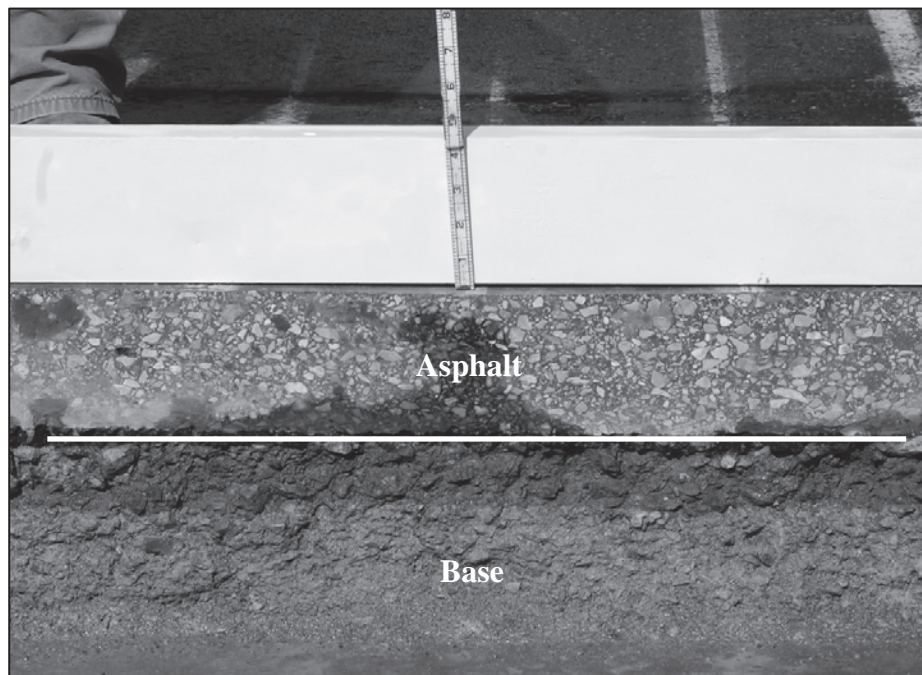
Figure 76. Repair PHP-2 trenched cross-section view post traffic.

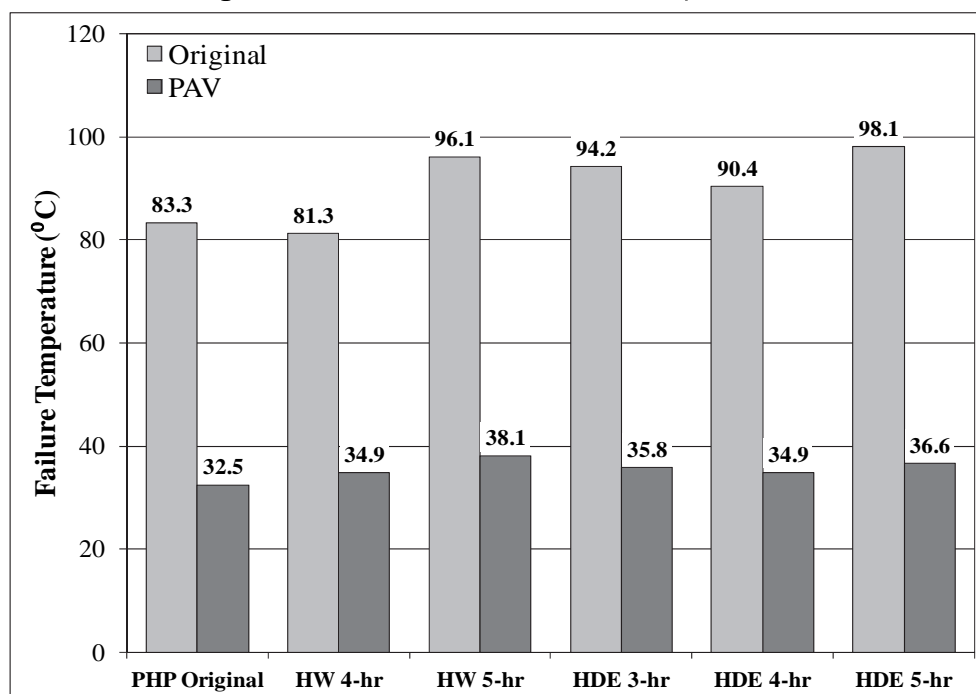
Superpave performance grade binder specifications were used to analyze the DSR data (1.0 kPa minimum for original binder and 5,000 kPa max for PAV aged binder). The failure temperatures from each sample for the original binder and the PAV aged binder are shown in Figure 82, respectively. Higher failure temperatures indicate stiffer binder. As shown, the original binder from the ERDC Test Site and the HW 4-hr specimen failed at similar temperatures, while the HW 5-hr specimen failed at a much higher temperature than the PHP original binder. The failure temperature of the HDE-3-hr specimen was higher than the HDE 4-hr specimen, and both were higher than the original PHP binder. The HDE 5-hr specimen had a noticeably higher failure temperature than the original binder. Since

the HDE 4-hr specimen was aged for a longer period of time, the failure temperature of the HDE 4-hr specimen was expected to be higher than that of the HDE 3-hr specimen. The sampling procedure used is believed to have caused this result, since some of the softer material under the hardened asphalt surface may have been inadvertently obtained during sampling.

Figure 82. Oxidation test binder failure temperatures.

Specimens were then subjected to aging in the Pressure Aging Vessel (PAV), which simulates long-term aging of asphalt binder specimens. As shown, the failure temperatures of the HW 4-hr and HW 5-hr specimens were greater than the PHP specimen. The HDE 3-hr, 4-hr, and 5-hr specimens had similar failure temperatures that were all slightly higher than the PHP binder. The higher failure temperatures values exhibited by the prematurely oxidized specimens indicate a possible decrease in the long-term performance of the repairs. Additionally, using this method to prematurely oxidize a pavement section appears to only stiffen the top ½ to 1 in. of the pavement as discussed previously.

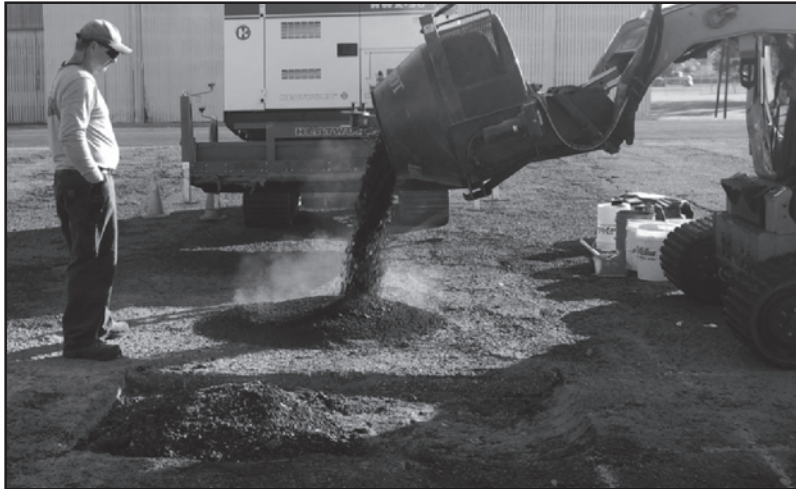
Figure A8. Rejuvenated asphalt being stockpiled near repair.

- 3.9. While the drum is still rotating, dump the rejuvenated material on the swept pavement surface adjacent to the repair void and return the CTL to the staging area to begin the next mix batch. Figure A8 shows an initial mix batch being stockpiled.

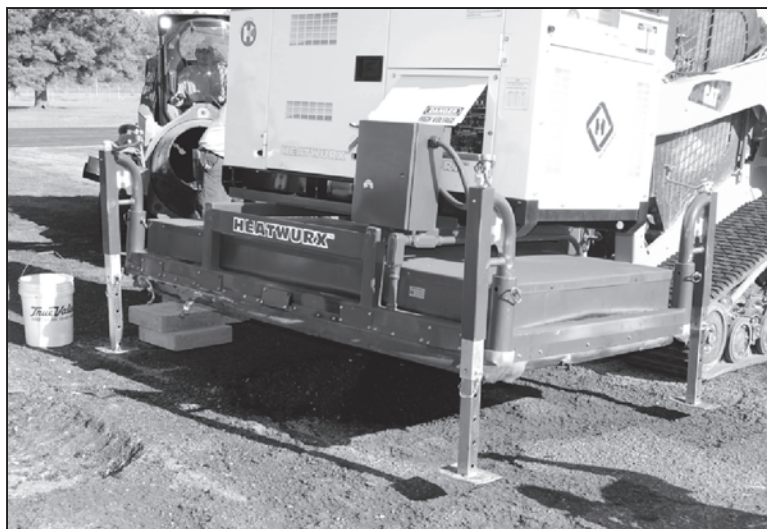
Figure A9. Heater placed over the rejuvenated stockpile.

- 3.10. Immediately place the heater unit directly over the rejuvenated stockpile to maintain its temperature during the remaining mix batches
 - 3.10.1. Use concrete blocks to elevate the heater to a distance away from the stockpile surface. This allows for temperature maintenance, yet prevents scorching over time. There is no specific distance; it will be dependent on variables such as wind speed and ambient temperature. Figure A9 illustrates the general positioning of the heater.

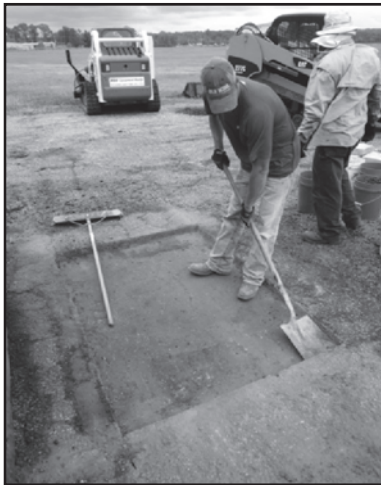
Figure A10. Final repair void preparation for partial-depth repair.

- 4.1. If the repair is partial-depth, prepare the repair void for placement by removing any foreign objects, fines and any remaining asphalt with a utility broom and hand shovel as shown in Figure A10. If the repair is full-depth (to the base layer), use a jumping jack tamper to compact and strengthen the underlying base layer as shown in Figure A11.
- 4.2. Regardless of repair type, use a hand pump sprayer to apply a light coat of rejuvenator to all interior faces of the repair void as shown in Figure A12.

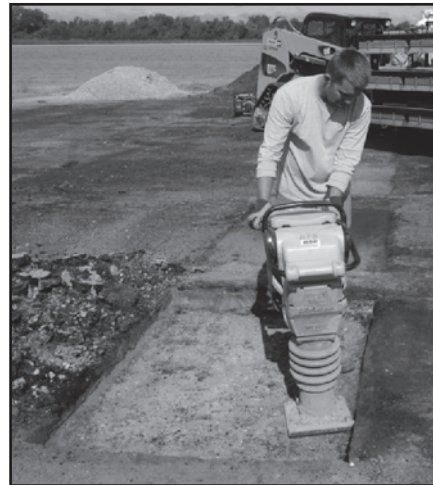
Figure A11. Base compaction for full-depth repair.

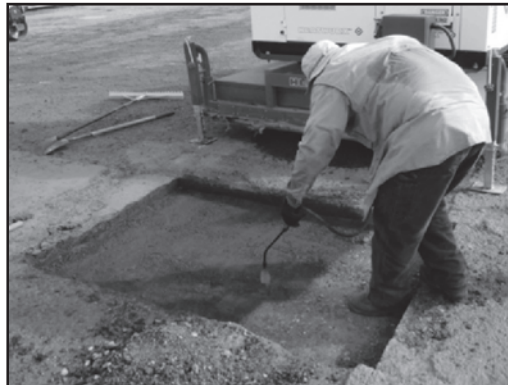
Figure A12. Rejuvenator applied to repair void.

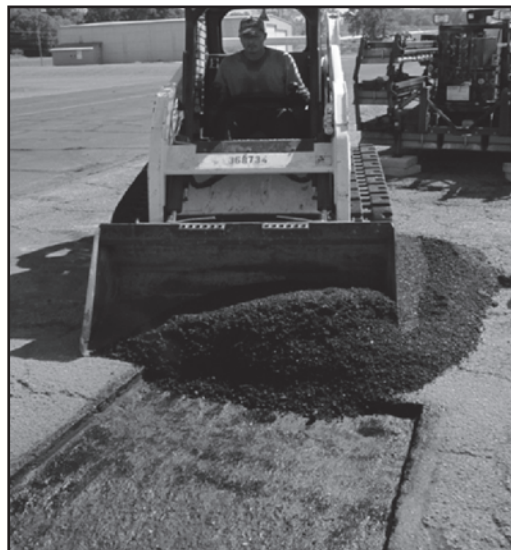
Figure A13. CTL placing rejuvenated material into repair void.

- 4.3. Use the CTL-mounted bucket attachment to push approximately one half of the stockpile into the adjacent repair void. This process is illustrated in Figure A13.

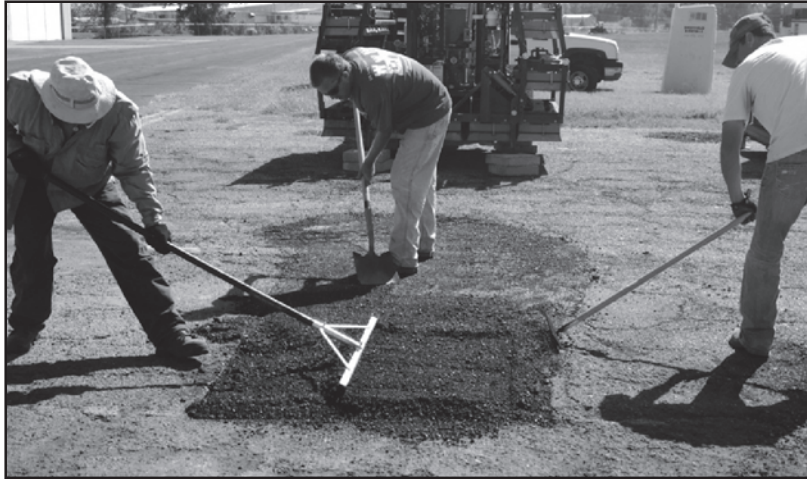
Figure A14. Preparing final lift for compaction.

- 4.4. Immediately begin using lute rakes and shovels to level the lift surface and prepare for compaction as shown in Figure A14.

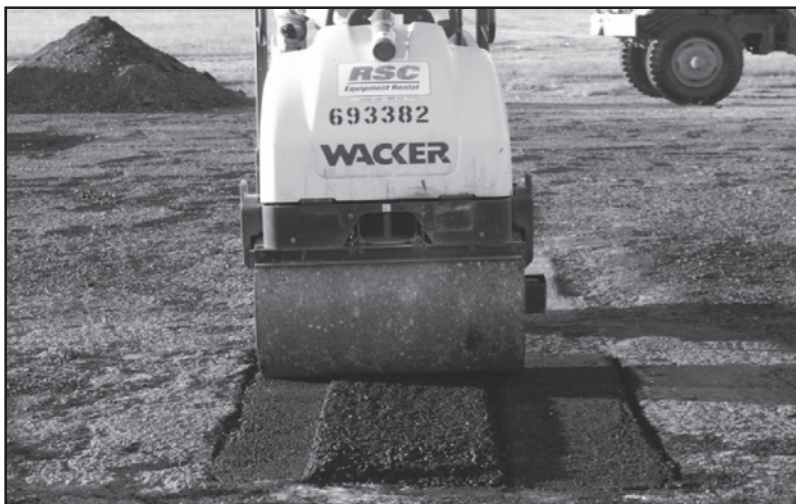
Figure A15. Compaction of final lift.

- 4.5. When performing full-depth repairs, place and compact material in a minimum of two lifts. Build small asphalt ramps within the void at each end of the first lift for compactor ingress and egress to avoid edge damage. Begin compaction on the first lift using the dual wheel vibratory roller.
 - 4.5.1. Compact the outer edges with vibration and then the center, working inward. Be sure to pinch edges first and then work inward as shown in Figure A15. Then, repeat the same traverse protocol, but now without vibration. Repeat this process until reaching the desired density.

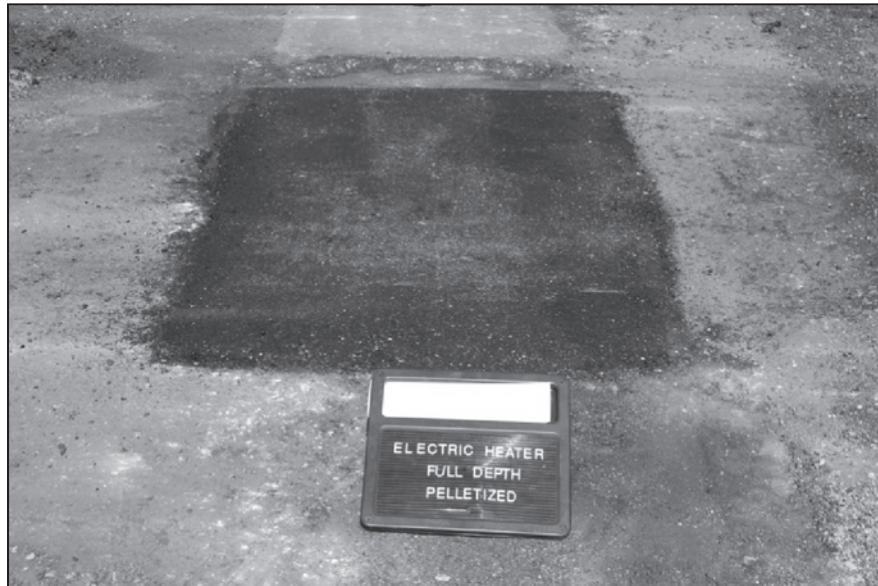
Figure A16. Final repair.

- 4.5.2. Use the CTL-mounted bucket attachment to push the remaining material into the void and repeat Step 4.5.1 on the second lift.
- 4.6. When performing partial-depth repairs, place and compact the material in one lift. Use Step 4.5.1 for compaction.
- 4.7. Use the laser gun to monitor and record the compacted lift surface temperature.
- 4.8. Place a calibrated nuclear gauge density machine at various locations across the repair to measure the average final repair density.
- 4.9. Allow repair to cool to a temperature of 70 °F (21 °C) before applying traffic.
- 4.10. Once this temperature is attained, the repair is considered complete. A final repair is shown in Figure A16.
